HAZARD ALERT

CRANE GEARBOX SHAFT FAILURE: LIEBHERR 200 HC TOWER CRANES

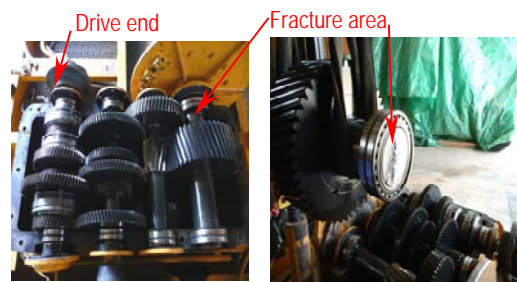
Shaft 1 2 3 4

Preliminary investigations of the hoist drive assembly exposed a broken output shaft (shaft 4), that is directly connected to the hoist drum. The hoist brake on this type of crane is located on reduction shaft 2.

When shaft failure occurs with this design of hoist gearbox, the hoist brake will be ineffective, allowing the crane's load to free fall.

Further investigation indicated that metal fatigue appears to have occurred, possibly due to a misalignment of the output shaft with the hoist drum. Further alignment

checks and a metallurgist's assessment are being undertaken to verify this.

It is essential to have a scheduled strip down, inspection and non-destructive testing programme for the gearbox shafts and bearings that meets the manufacturer's specifications.

1. Check the alignment of the output shaft with the hoist drum shaft, to the manufacturer's specifications. This must include bearing alignment and condition, and fastener integrity.
2. If the alignment is out of tolerance, immediately remove the gearbox, strip down all shafts and bearings, and carry out non-destructive testing for cracks, unless otherwise justified by a professional engineer.
3. Maintain this procedure as part of the documented major inspection programme.

It is critical for the gearbox output shaft to be correctly aligned with the hoist drum. Failure to inspect and test to ensure this is likely to lead to a catastrophic failure of the output shaft.
