Safety Alert

Issued March 2018

Asbestos and Air Conditioning Ductwork

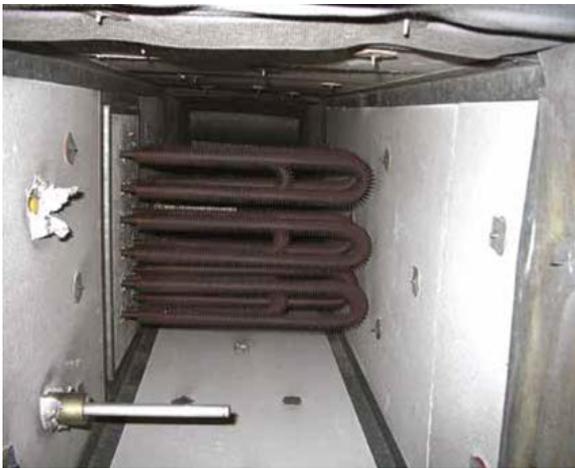
Asbestos-containing millboard was once widely used in the construction industry due to its flame-resistant properties, and commonly used to line compartments containing heat or spark-producing electrical equipment. In particular, asbestos-containing millboard surrounded reheating banks or coils throughout the ductwork of air conditioning units.

Asbestos lining within a heater bank.

Asbestos-containing materials, such as millboard, that are intact and in good condition are not hazardous to building occupants under normal conditions. However, asbestos becomes a health risk when fibres are released into the air and inhaled. The length and frequency of exposure may impact the risk of

developing asbestos-related diseases such as asbestosis, mesothelioma and lung cancer. The main concern with old systems is to avoid accidental or inappropriate disturbance without correct safety procedures in place.

SafeWork SA, as the compliance authority for work health and safety legislation, affirms that this millboard lining as well as other suspected asbestos-containing components of old heating and air conditioning systems should be identified as containing asbestos and removed prior to demolition (regulation 452) or refurbishment (regulation 456), so that the exposure risk is minimised.

If refurbishment or replacement of the heater bank ductwork for a building has not taken place in the past 30 years, SafeWork SA recommends the following action should be taken:

- check the building's asbestos register for a note that millboard lining in the heater banks has been identified or removed;
- if not identified or removed, add the issue to the building asbestos register for future workers; or
- if accessible, label the ductwork adjacent to the heater banks in line with the requirements of the WHS Regulations for labeling asbestos-containing materials (regulation 424).
