# Hazard Alert

## Road roller reverse travel

Government  
of South Australia  
SafeWork SA

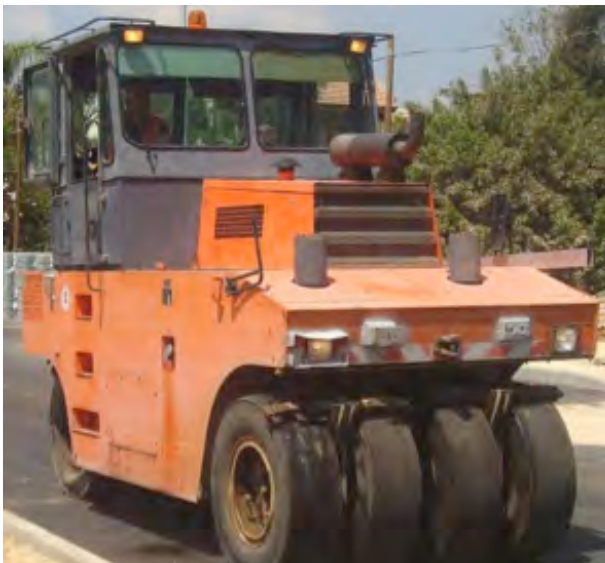
*Example of a multi-tyred road roller*

Road rollers generally operate in a forward and reverse motion to effectively and efficiently compact the road surface. Although the road roller has steering control, it may not be physically possible to turn the vehicle around at the end of every pass.

The operator seat may not be centrally positioned which can reduce visibility between forward and reverse motion. For example, where the operator seat is fixed in a forward facing direction, the operator must look over their shoulder while reversing. When this activity is performed for long periods of time, operator fatigue and confusion may occur.
