# Safety Alert

Issued February 2018

## In situ grain silos

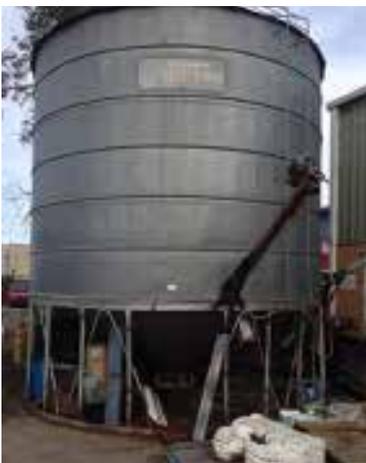
Example of an in situ silo used on farms for storage of grains and legumes.
